Shed Problem on Older Compact Gilmore Looms

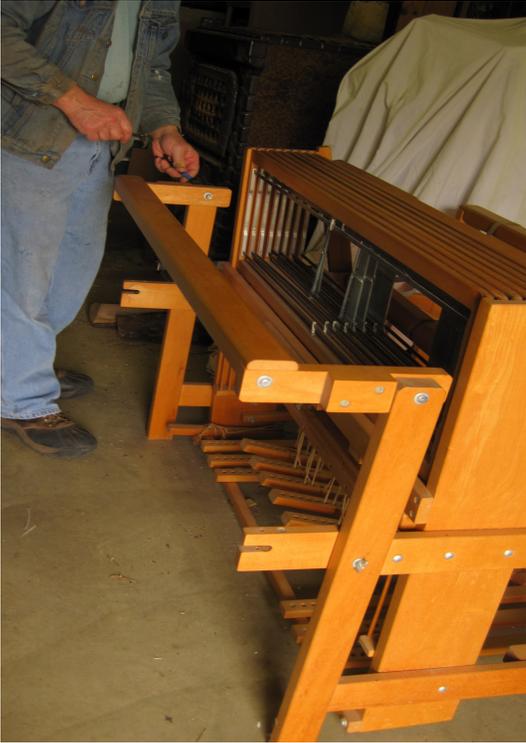
Top Back Beam in its original position

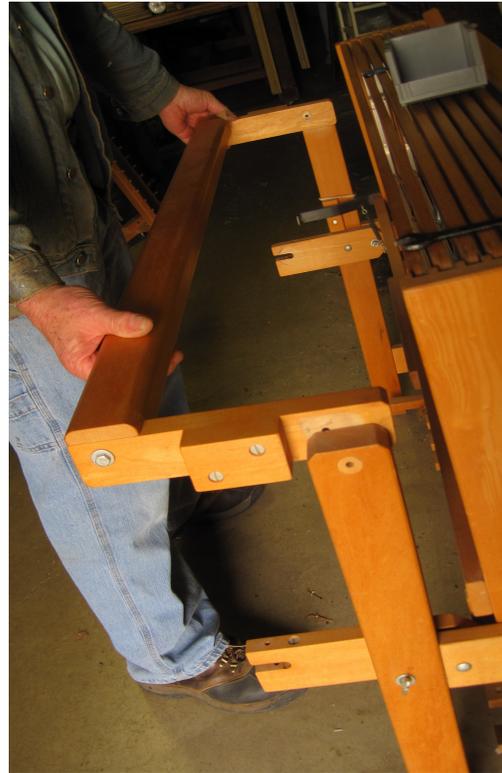
Top Back Beam and Arms unbolted

1. The Back Top Beams is attached to "Arms" that swing the Beam up in a vertical position or swing it down to rest in a horizontal position. These Arms are attached by a bolt that has 2 nuts locked against each other. The first thing you will want to do is unlock these nuts and remove the bolts from both Arms, thus freeing the Back Top Beam/Arms assembly from the legs. (see Photo captioned "Top Back Beam and Arms unbolted" below)

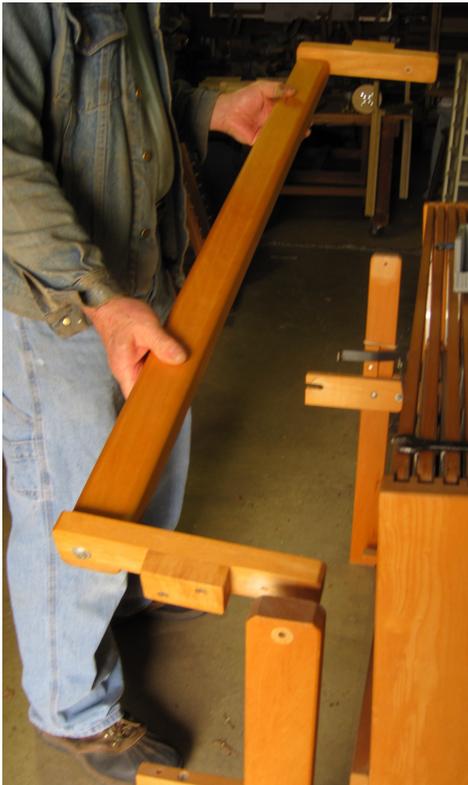
Top Back Beam Flipped Over

2. Take the assembly from above and put the right side to the left and left to the right with the beam still out to the back of the loom. Basically flipping it 180 degrees. (see Photo captioned "Top Back Beam Flipped Over" below) This puts the Back Top Beam upside down. Re-bolt the Arms back in this position. Tighten the nuts down so the arms are not too loose and re-lock the nuts against each other.

3. Flipping the Beam basically puts it 1 1/2" lower and has been found to eliminate most all of the shed loss due to a tight warp. There might, or might not be, a loss in the ability of the Back Top Beam and its arms to rotate vertically upward as needed to make the loom narrower for a doorway. But it can always be unbolted again if necessary.

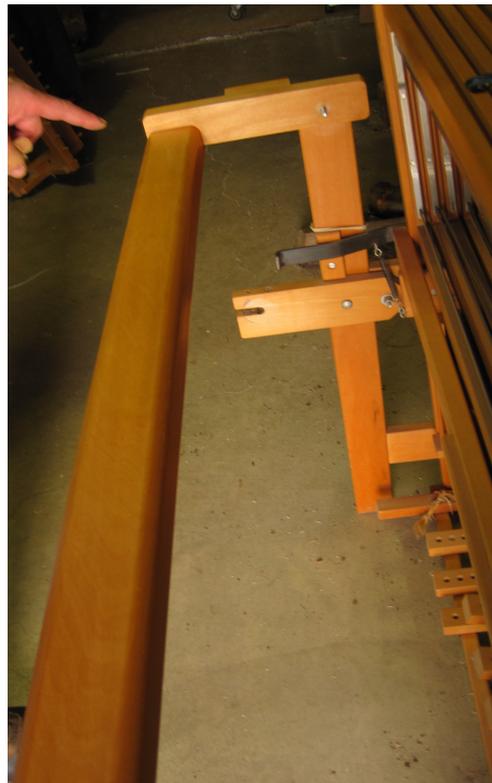
Top Back Beam Bolted Back In
